## Entrances

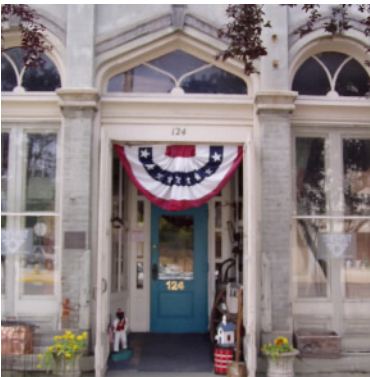
Many entrances are flush with the building facade, recessed entrances (in an alcove used to accentuate the entry to a building or store) are also common.

- Primary entrances should be clearly marked and provide a sense of welcome and easy passage from exterior to interior.
- The features of a building's entrance, including pilasters and columns should be preserved and repaired rather than replaced.

- Where the entrance was originally recessed, it should be preserved to provide overhead protection from the elements. They also provide a clear area for out-swinging doors and offer the opportunity for interesting paving patterns, signage, and displays.
- The style and character of the door and its hardware should be compatible with the design of the storefront and the scale of the building. Doors should also include glass panels to maximize visual access to the interior of the building.
- Using stock commercial and residential doors should be avoided.
- Replacement doors should match the building's original opening and configuration.

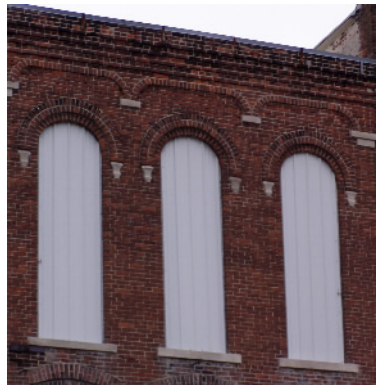
*Inappropriate upper windows*

- Original upper story window openings should be restored and reglazed. The proportions of the restored windows and rhythm of the window openings should be true to the original design as possible.
- Instead of replacing original glass with double-glazing, thermal upgrade should be achieved by installing or replacing inadequate or damaged weather stripping and caulking.
- Replacing multi-sashed windows with a single span of glass is not appropriate.
- The use of mirrored or tinted glass is not appropriate and is to be avoided.
- If decorative elements are missing, those elements should not be recreated unless strong pictorial, historical, or physical documentation exists.

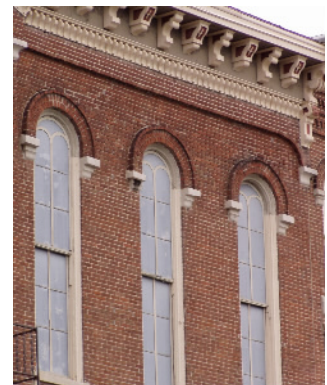
*Appropriate upper windows*
